# Meadow Lake Aquatic Vegetation Assessment Report

**ECT**

August 7, 2014

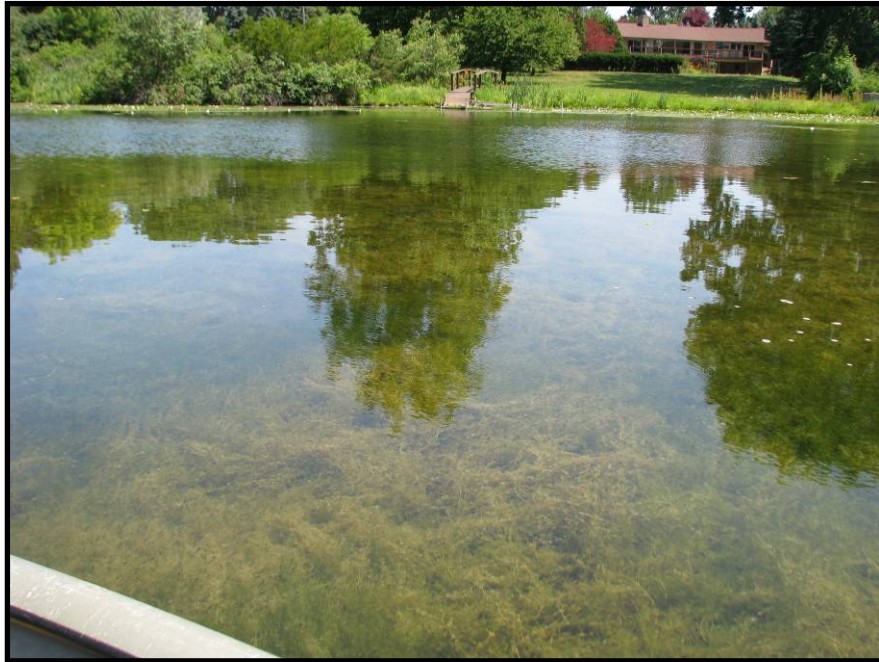
A total of 16 different aquatic plant species were identified during the site (Table 1). The number of species present within each AROS unit ranged from 1-9, with white waterlily and starry stonewort being the most frequently observed species. Starry stonewort and chara were dense throughout many sections of the lake (Figure 1), however; some instances contained isolated patches rather than large beds of the plant. Other common plants identified in smaller abundances included whorled watermilfoil, thin leaf pondweed, and sago pondweed. Despite this, many of these species occurred in isolated sections of the lake and were not widely distributed. For instance, thin leaf pondweed and whorled milfoil were found only in the southern and southwestern sections of the lake.

**Figure 1.**  
**Typical starry stonewort beds that were prevalent in many areas of Meadow Lake during sampling surveys.**

- 2) Because the current treatment practices seem to ineffectively control starry stonewort, ECT recommends the management board hire an independent firm to test the effectiveness of the copper sulfate ( $\text{CuSO}_4$ ) treatment on starry stonewort within Meadow Lake and recommend other potential treatment approaches.

- 3) Finally, ECT recommends whole-lake restoration. Nutrients stored within the soil from long-term buildup may reduce the effectiveness of vegetation management attempts. Furthermore, it may now be impossible to effectively manage starry stonewort given its extensive colonization of the lake. Whole-lake restoration should include dewatering of the lake, mechanical dredging and grading to remove the high-nutrient sediments, shaping of the lake bottom to improve habitat, and disposal of dredged sediment. Following dredging, habitat structures should be installed at sites within the lake that would provide spawning, nursery, cover, and feeding sites. Habitat structures could include, but are not limited to, gravel/sand substrate, woody debris (i.e. logs), vegetation, and variable lake contours (e.g., shelves/flats, dropoffs, etc.).

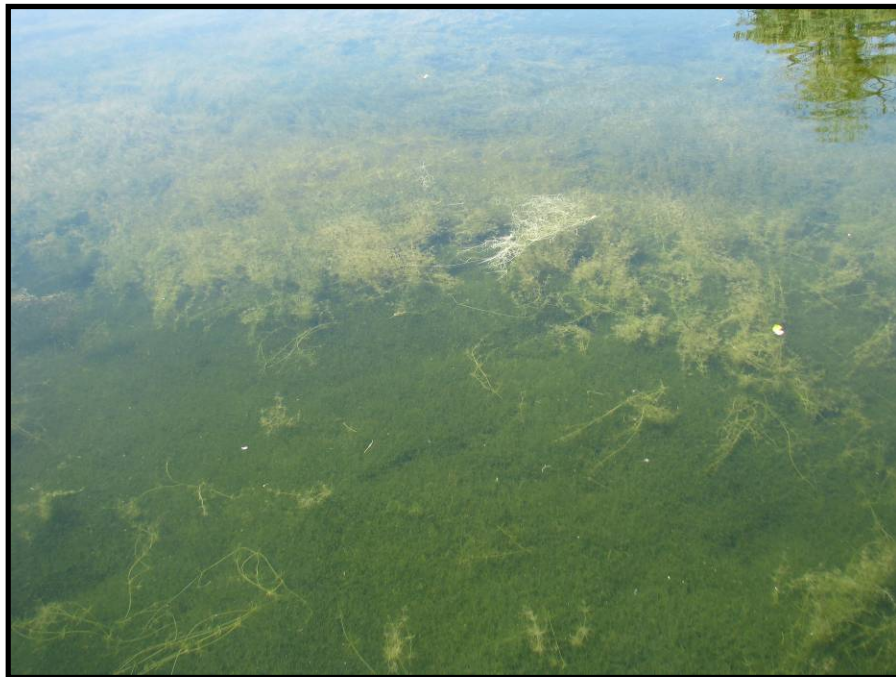
**Figure 2.**  
**Extensive starry stonewort and charophyte growth occurring in Meadow Lake during sampling surveys.**

Current aquatic herbicide applications are not effectively chara and starry stonewort. Chara and starry stonewort are still widely prevalent within many sections of the lake, covering extensive areas of the lake bottom. Chara is a common algal form in groundwater fed lakes that typically covers extensive bottom areas in such systems due to its use of minerals present at high concentrations in the water of groundwater fed lakes. Stonewort, on the other hand, is not native to Michigan lakes and has become a more common aquatic vegetation management problem. With continued growth of starry stonewort, the plant can become widespread and fill the entire water column of the lake at times. This creates major problems by destroying fish habitat (spawning, nursery, and cover) and desirable native aquatic macrophytes. It also creates low dissolved oxygen that can cause fish kills.
